Mastersizer 3000 software v3.87 (PSS0223-35)

Software update notification

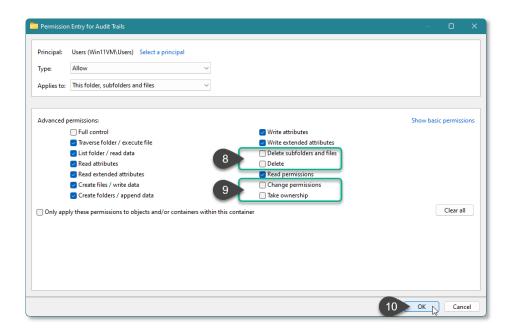
- 9. Left-click to select the check-box for Replace all child permission entries with inheritable permission entries from the object (11) and left-click the Apply button (12).
- 10. Left-click the Yes button (13) when prompted to replace the permissions and the OK button (14) when you return to the previous window.

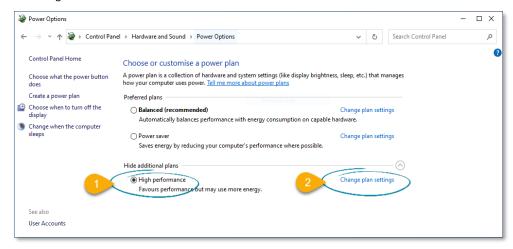
4. From the Edit Plan Settings window, click on Change advanced power settings.
