MORPHOLOGI SOFTWARE: v10.34 (PSS0065-09)

Software Update Notification

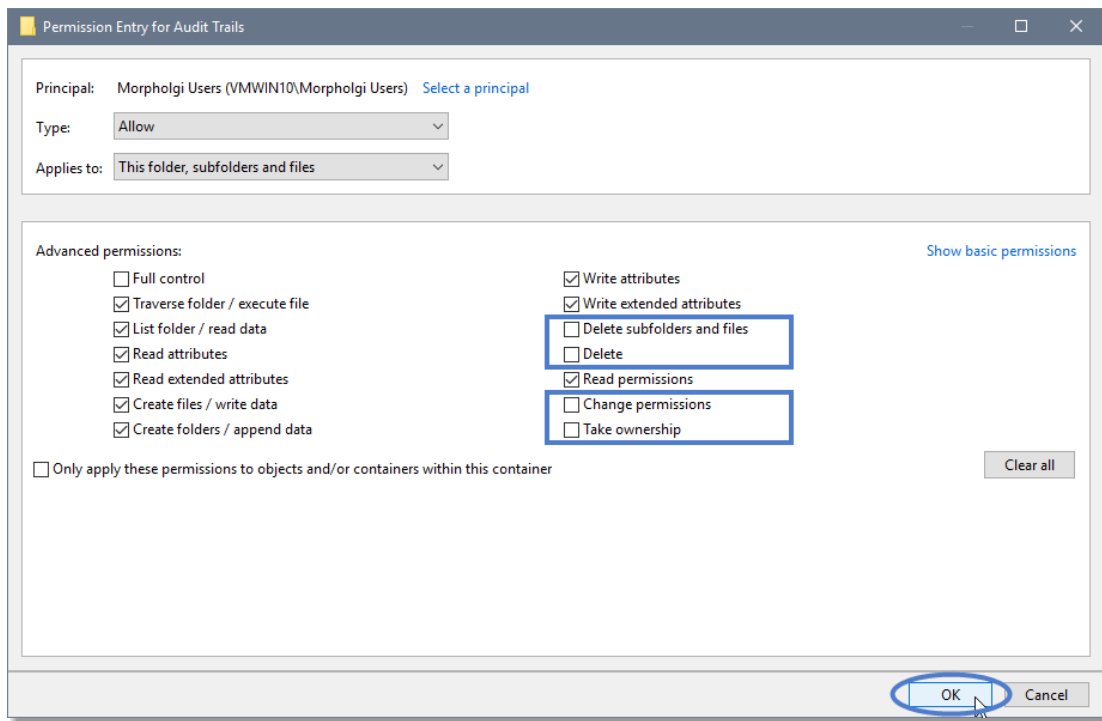
8. Left-click **Replace all child permission entries with inheritable permission entries from the object** and left-click the **Apply** button.
9. Left-click the **Yes** button when prompted to replace the permissions and the **OK** button when you return to the previous window.

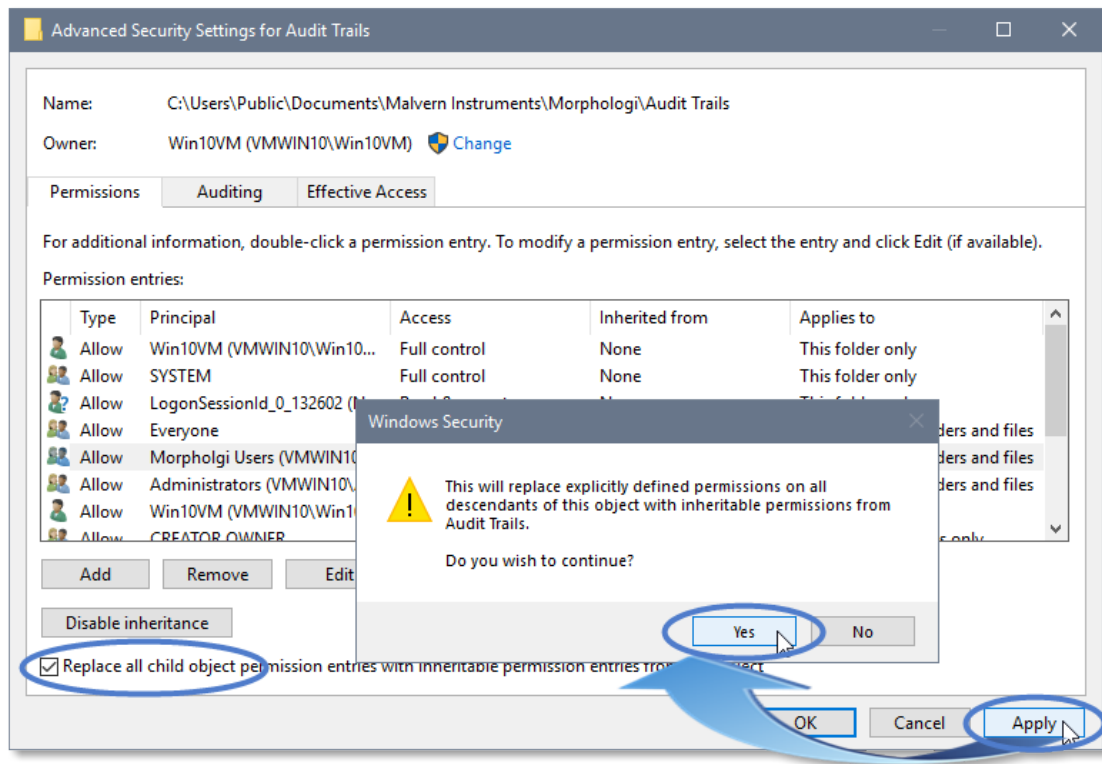
10. Left-click the **OK** button when you return to original folder properties window.
