SOFTWARE UPDATE NOTIFICATION (SUN) – OMNISEC SOFTWARE v10.30: PSS0051-04

MOLECULAR WEIGHT

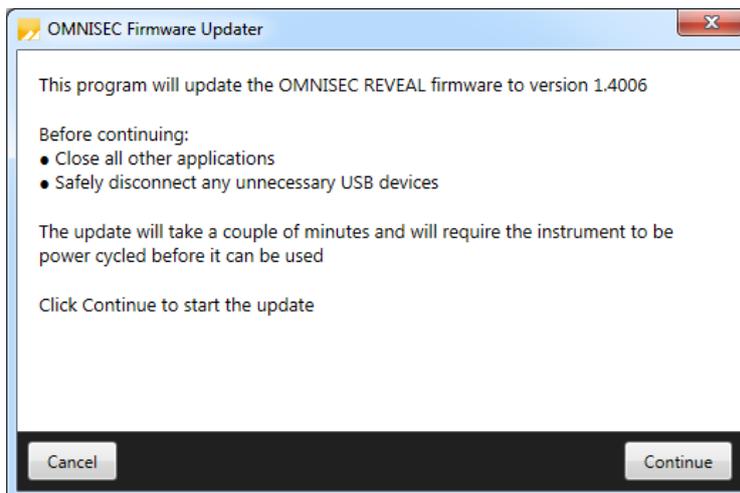
When the OMNISEC Firmware Updater launches, you should carefully read the information presented to you before continuing. Click **Continue** to start the update process.

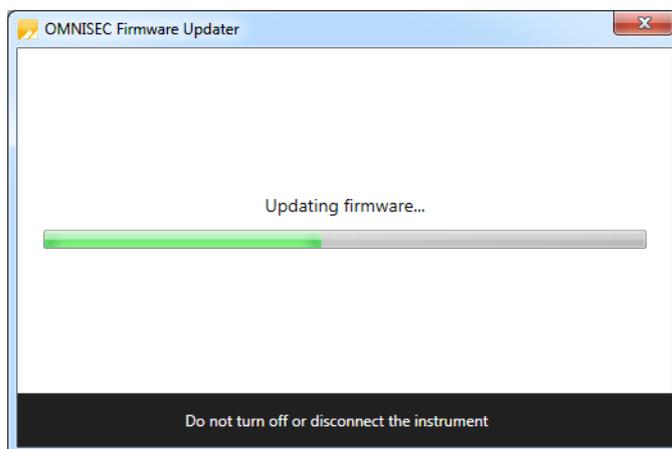
The update process takes several minutes. It is recommended that you do not do anything else on your computer during the update.
