SOFTWARE UPDATE NOTIFICATION (SUN) – OMNISEC SOFTWARE v10.31: PSS0051-05

MOLECULAR WEIGHT

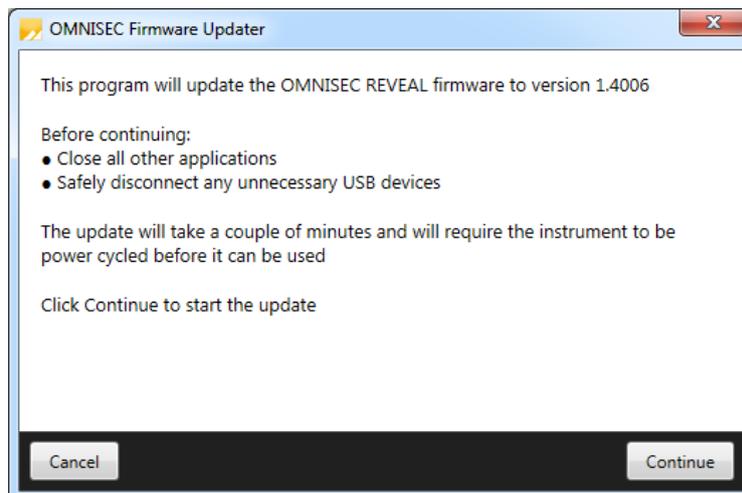
When the OMNISEC Firmware Updater launches, you should carefully read the information presented to you before continuing. Click **Continue** to start the update process.

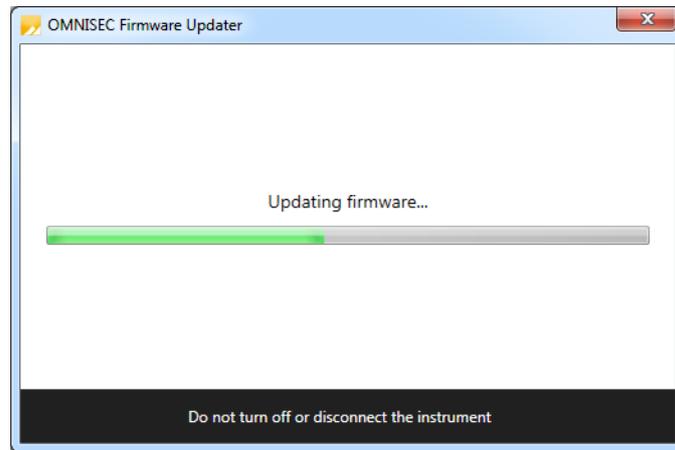
The update process takes several minutes. It is recommended that you do not do anything else on your computer during the update.
