MORPHOLOGI SOFTWARE: v11.02

(PSS0065-12)

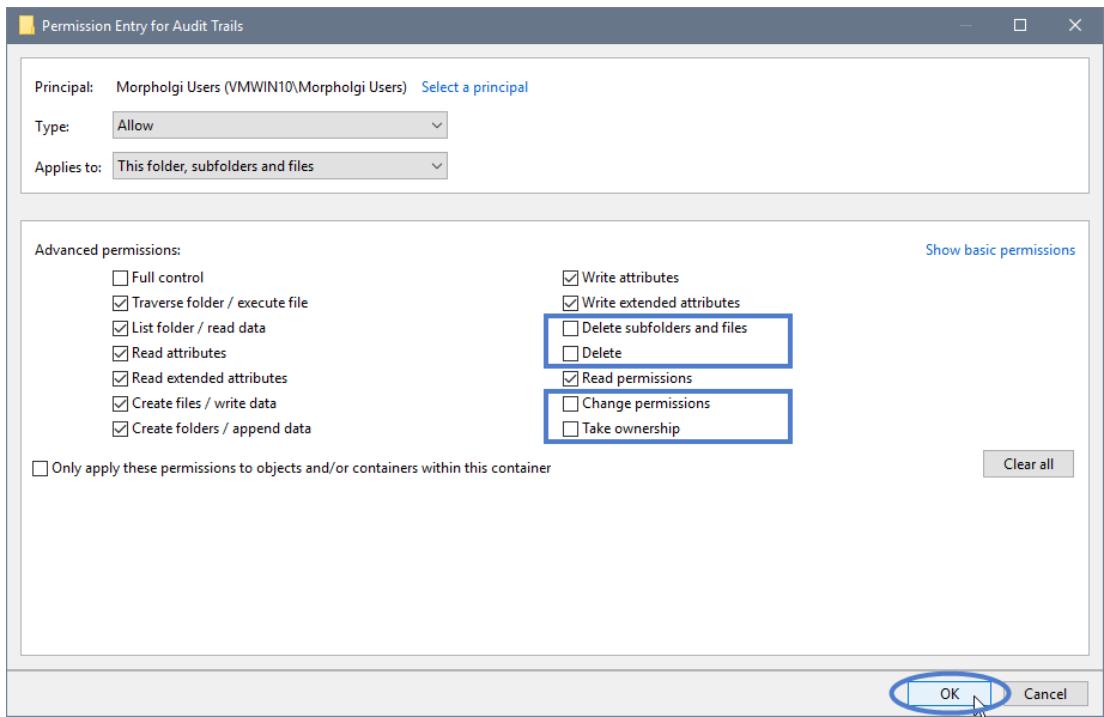
8. Left-click **Replace all child permission entries with inheritable permission entries from the object** and left-click the **Apply** button.
9. Left-click the **Yes** button when prompted to replace the permissions and the **OK** button when you return to the previous window.

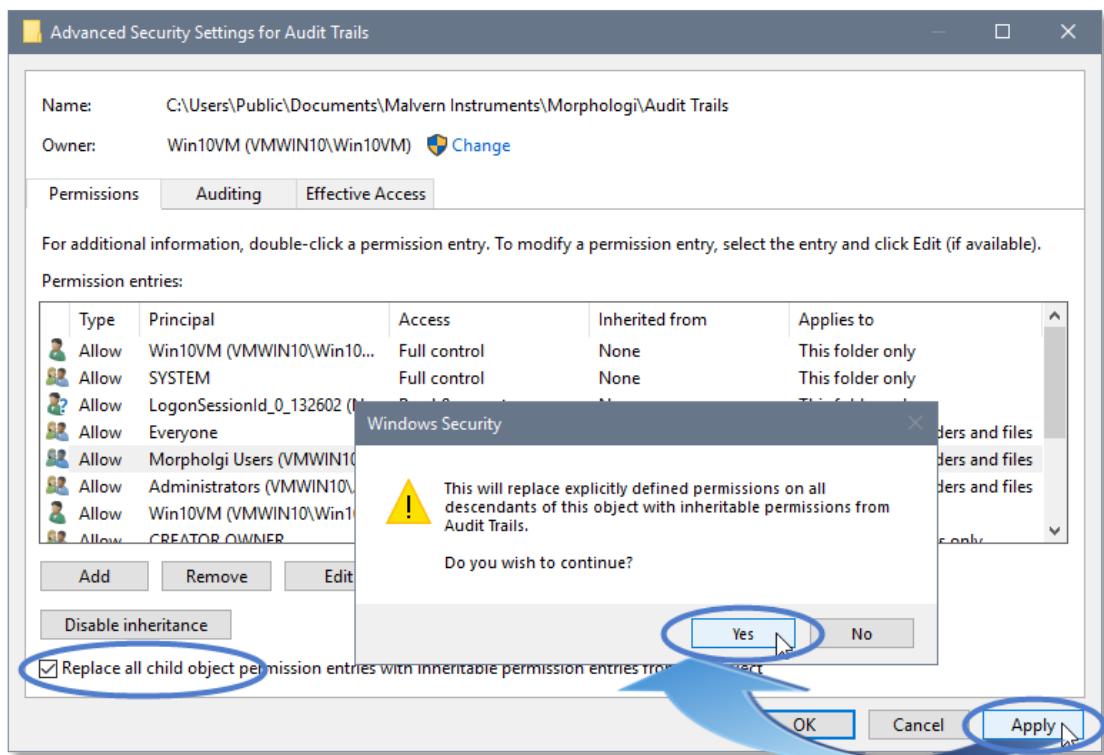
10. Left-click the **OK** button when you return to original folder properties window.
