# MORPHOLOGI SOFTWARE: v11 (PSS0065-10)

## Software Update Notification

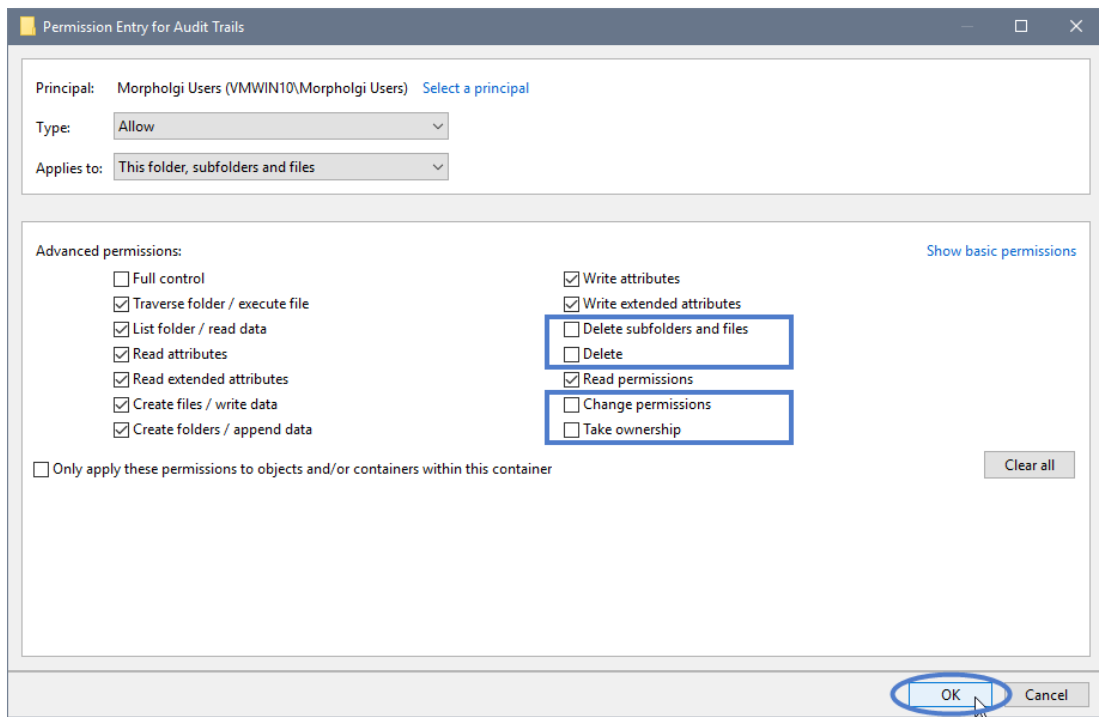
8. Left-click **Replace all child permission entries with inheritable permission entries from the object** and left-click the **Apply** button.
9. Left-click the **Yes** button when prompted to replace the permissions and the **OK** button when you return to the previous window.

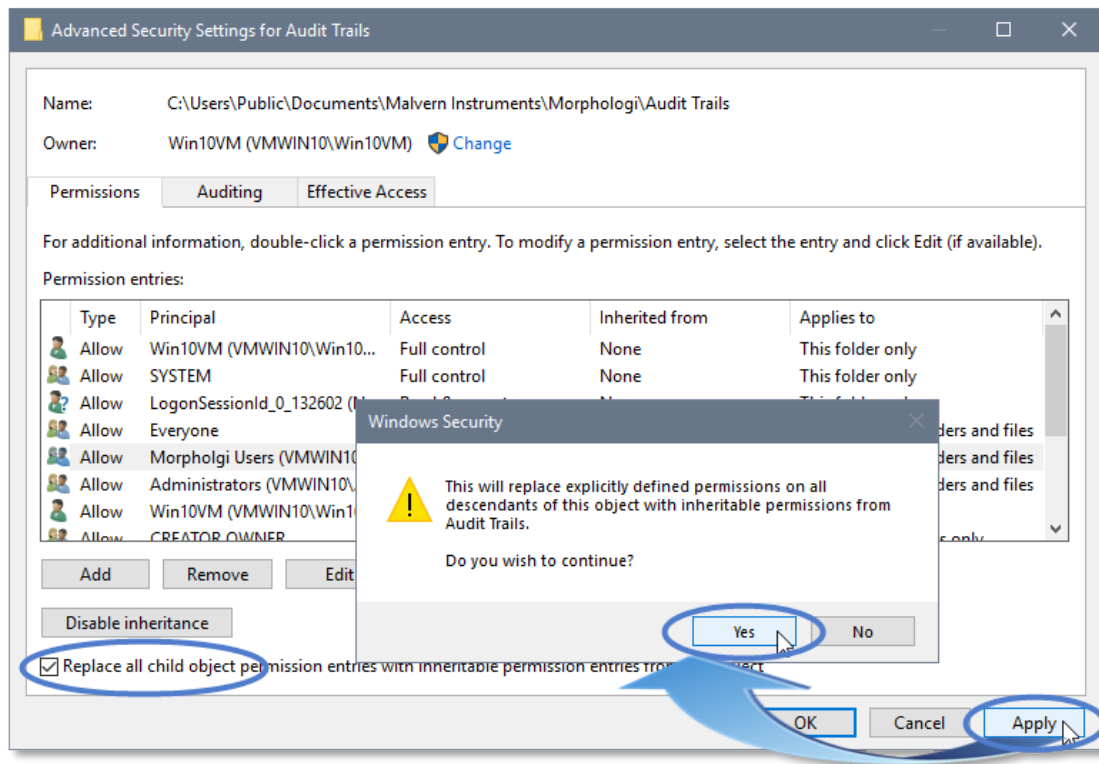
10. Left-click the **OK** button when you return to original folder properties window.
