# MORPHOLOGI SOFTWARE: v11.02 (PSS0065-12)

## Software Update Notification

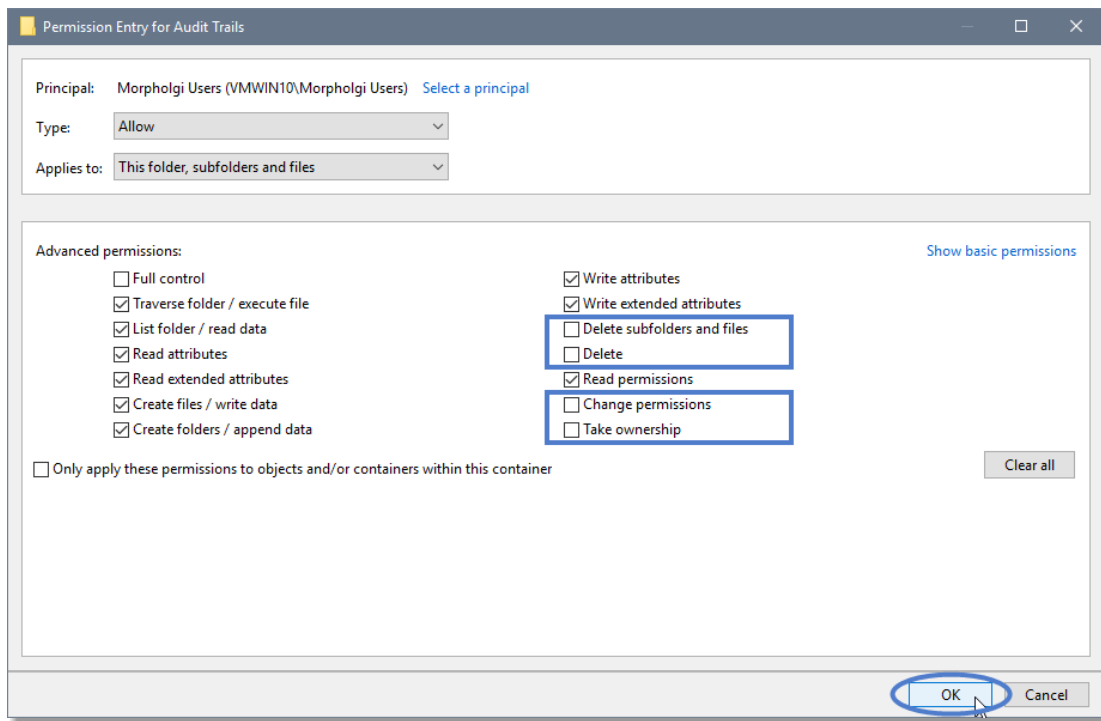
8. Left-click **Replace all child permission entries with inheritable permission entries from the object** and left-click the **Apply** button.
9. Left-click the **Yes** button when prompted to replace the permissions and the **OK** button when you return to the previous window.

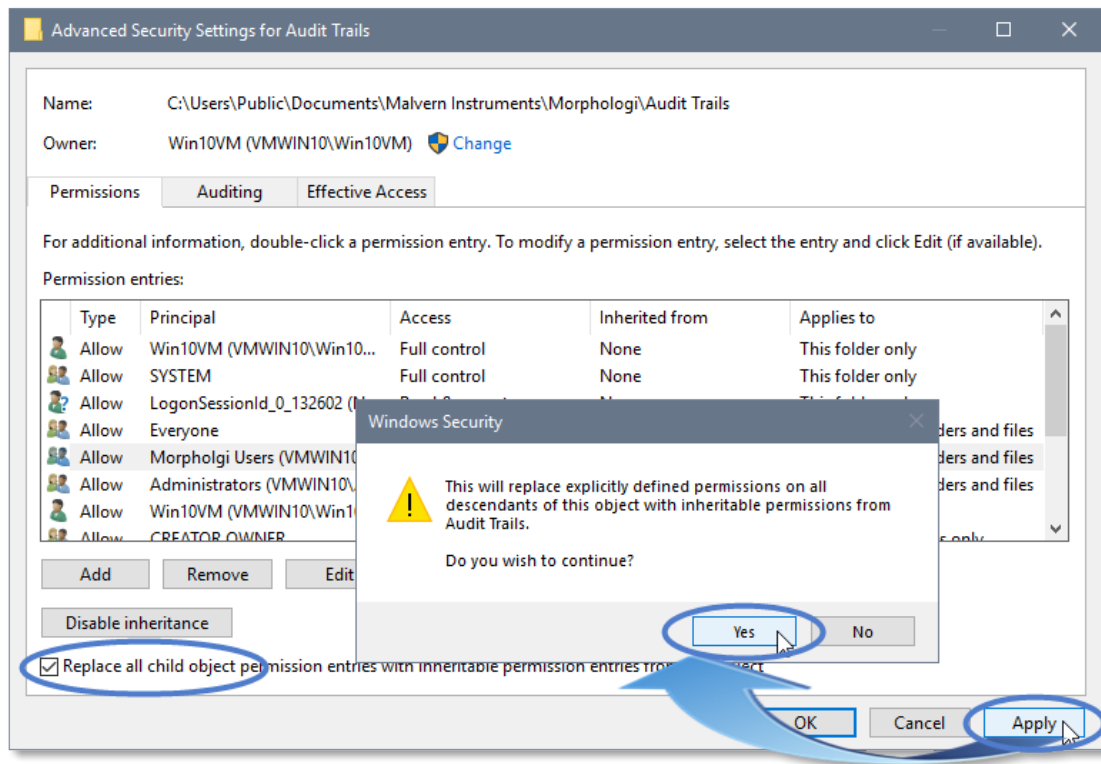
10. Left-click the **OK** button when you return to original folder properties window.
