SOFTWARE UPDATE NOTIFICATION (SUN)

Viscotek DSV SOFTWARE: PSW0109

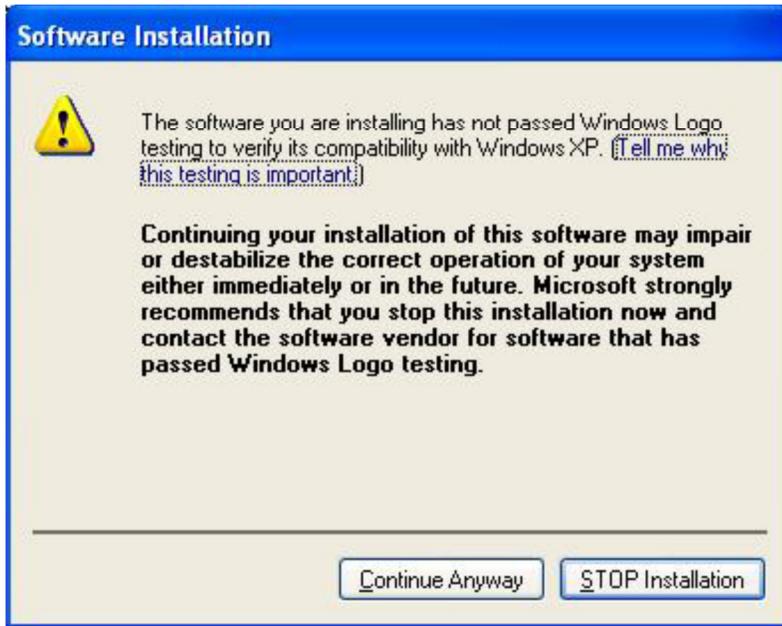
This warning can safely be ignored as the software installation has been fully tested on Windows XP. If this warning is encountered the button, 'Continue Anyway' should be selected.
