Software Update Notification

File Name : QSpec Update Notification.pdf

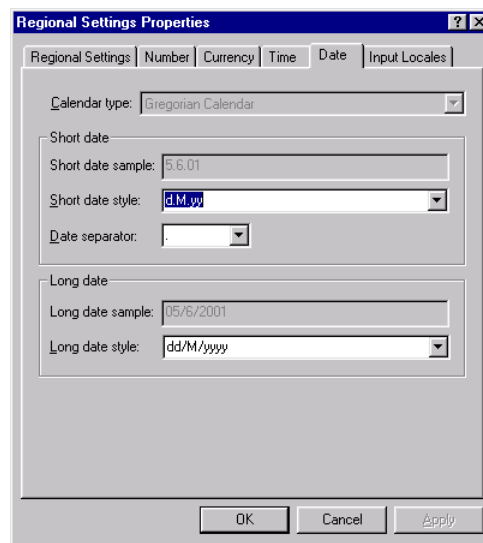
With the default long date style being longer than the original presentation method, some reports may not have enough space to fit the text. If this is the case, either use Report Designer to modify the reports or modify the date presentation style to dd MMM yyyy, as shown in the example above.

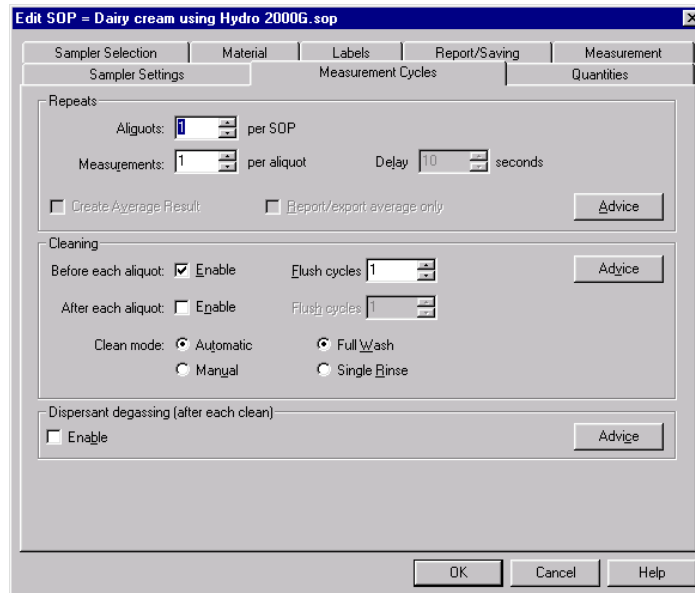
7.4 Improved diagnostics on the Hydro 2000µP.

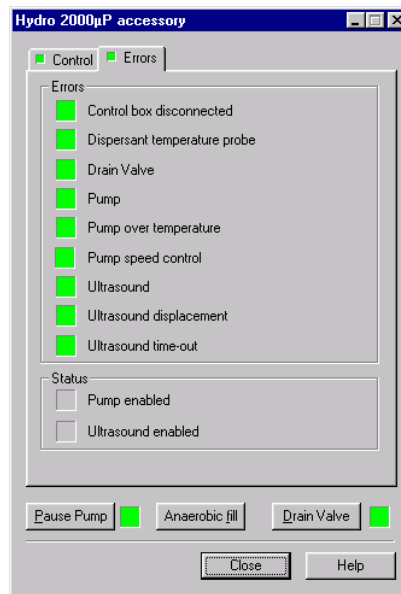
7.5 Safety cut out on the Hydro 2000µP Ultrasonics.
